SI 1856
For technical personnel only!
1/2

SERVICE INFORMATION

WATER PUMPS FROM AUDI/SEAT/ŠKODA/VW

DANGER OF BREAKAGE: NOTE DURING FITTING!

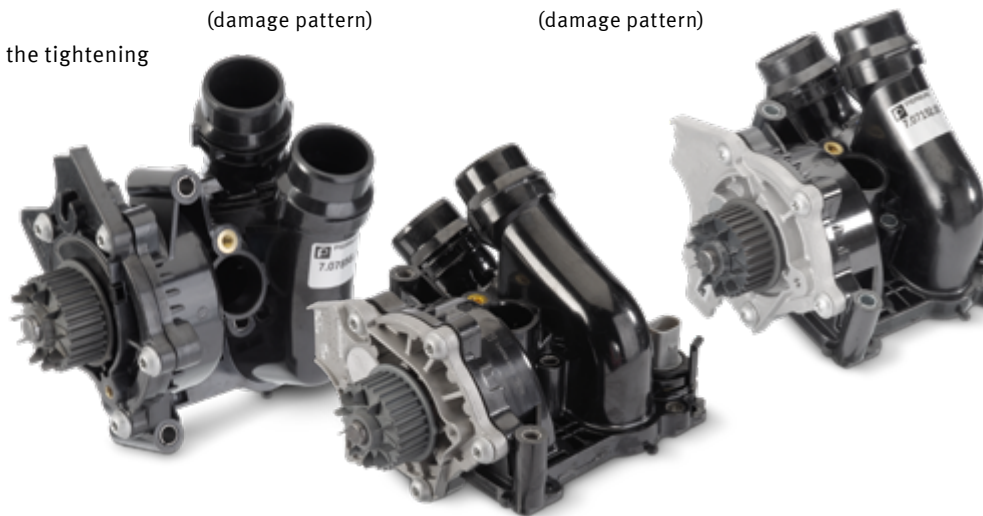
Fig. 1: View of product

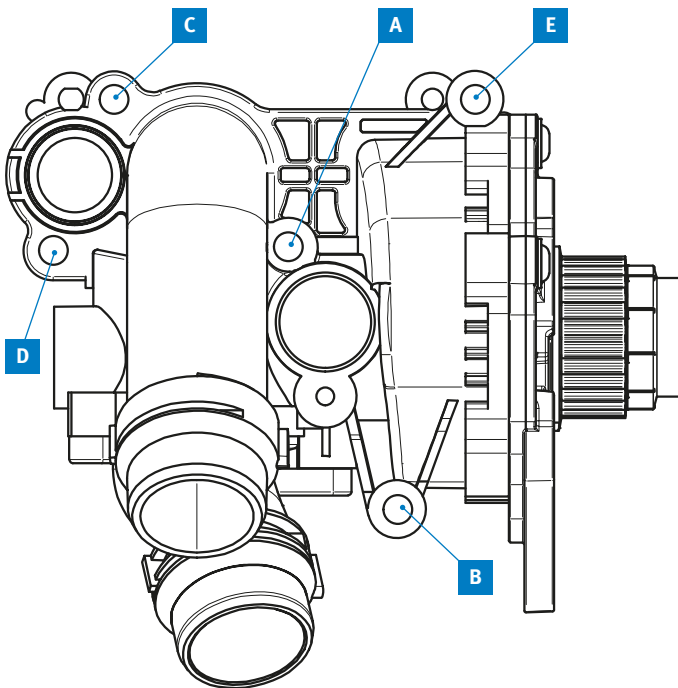
Fig. 4:
Sequence of the screw connection [A] – [B] – [C] – [D] – [E]

- The sequence for tightening the bolts must be followed (Fig. 4): [A] – [B] – [C] – [D] – [E]
- Tightening torque: 9 Nm
- Risk of injury:
Only remove yellow protective cap** (Fig. 6) on the ventilation wings after installation.

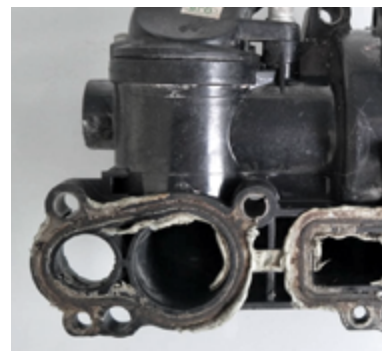
Fig. 5: Leakage due to additional sealant (damage symptoms)

- All gaskets of this water pump are exclusively designed for use with cooling liquid. They must never be oiled, e.g. with engine oil.
- The area around the installation location and the coolant agent must also be free from impurities.
- Contact with oil could cause the gaskets to swell in their groove, and the housing of the pump may break.
- Do not use additional sealant. The pump may develop leaks (Fig. 5).

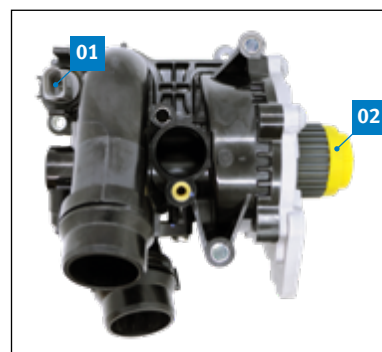
Fig. 6:
01 Temperature sensor*
02 Yellow protective cap**

Minor leakage of cooling liquid at the leakage hole is due to the design and does therefore not constitute reason for complaint. Depending on the version of the water pump, the temperature sensor* (Fig. 6) is either pre-assembled or included separately.
